Snohomish Carnegie Library
A Rehabilitation Master Plan
February 2005

BOLA Architecture + Planning

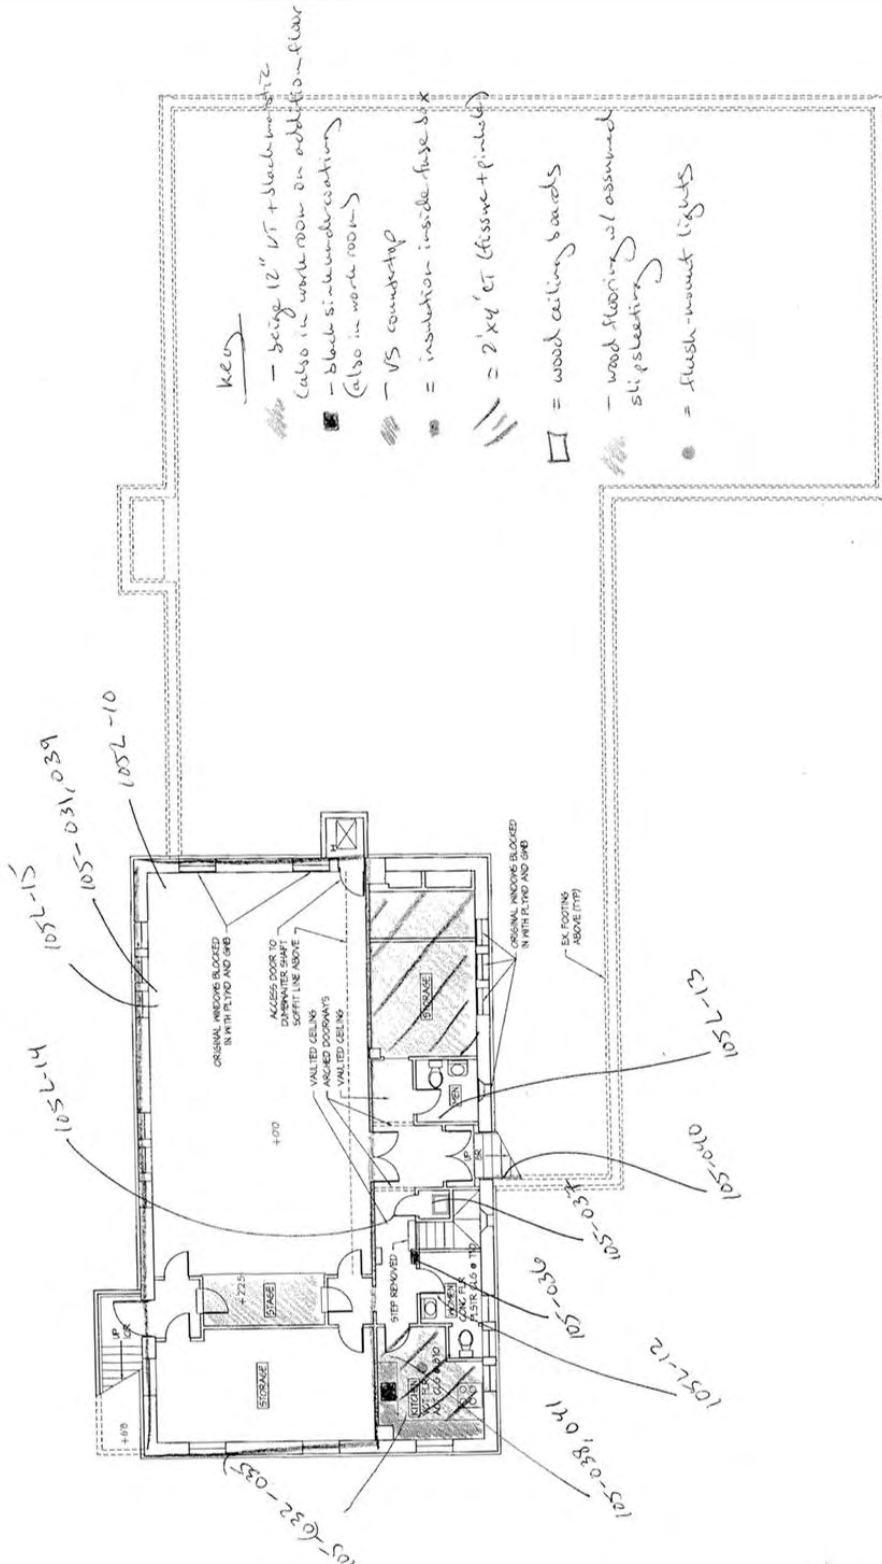
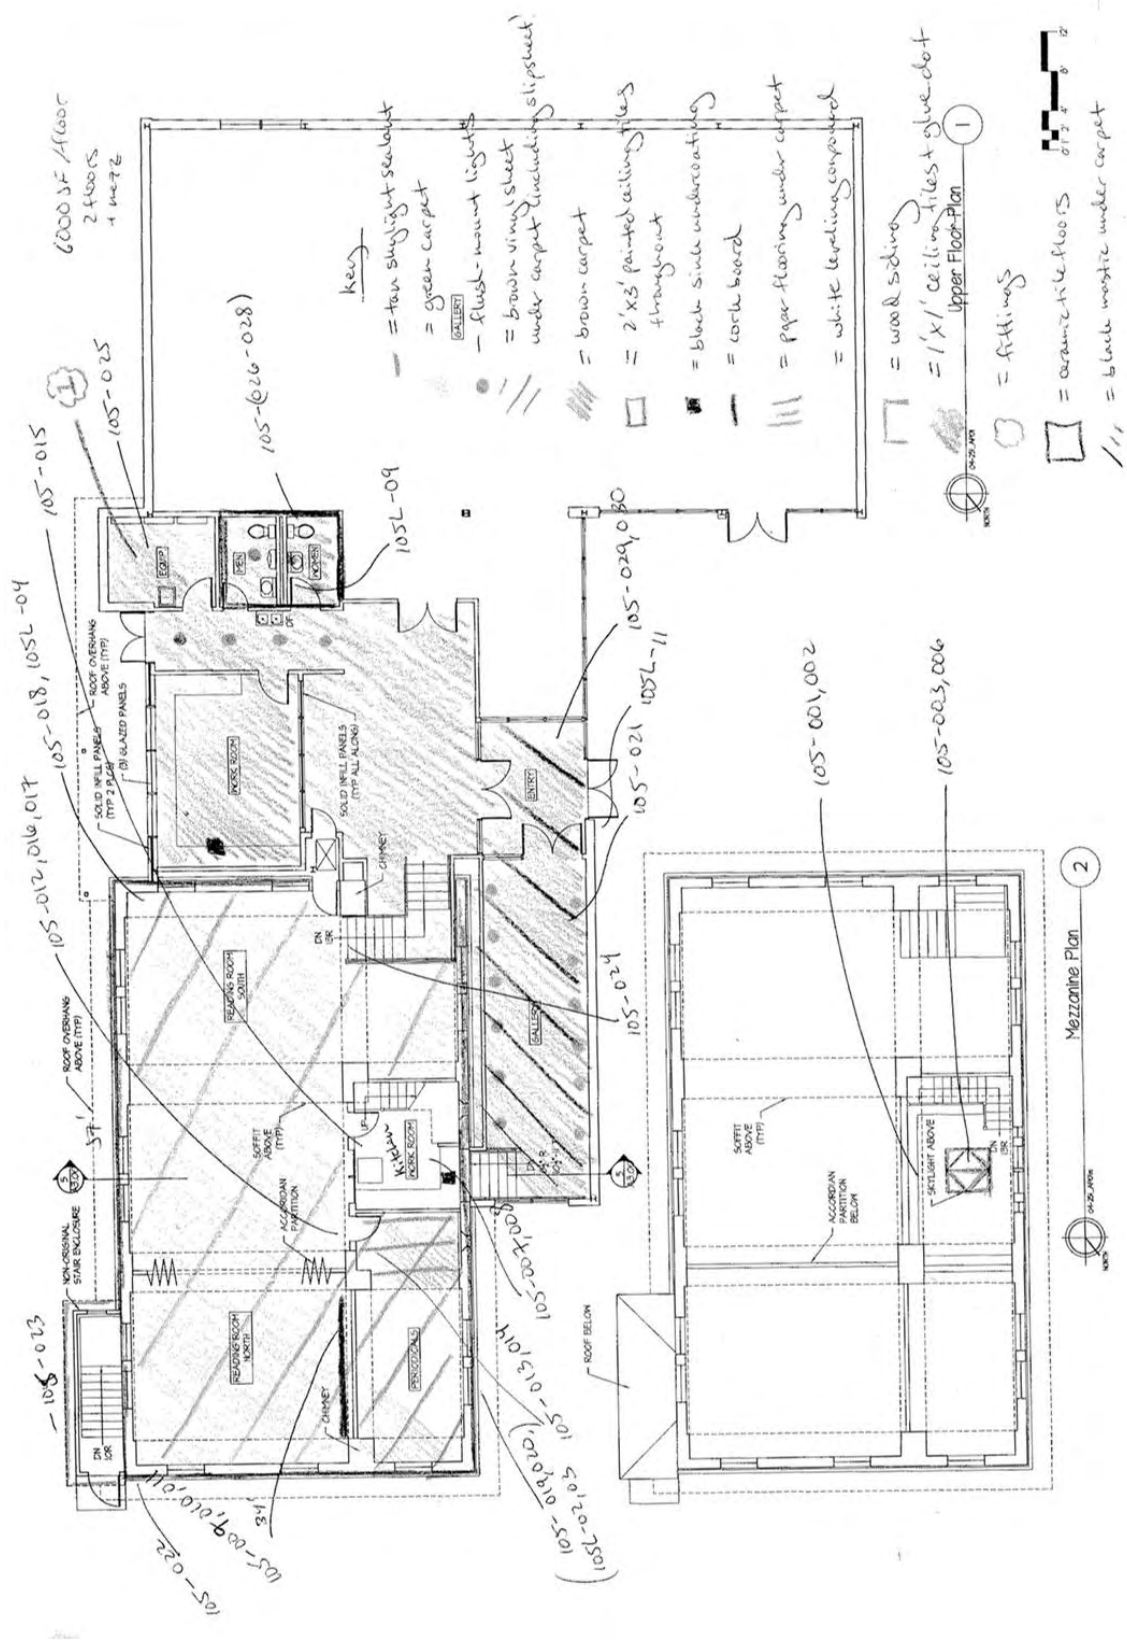
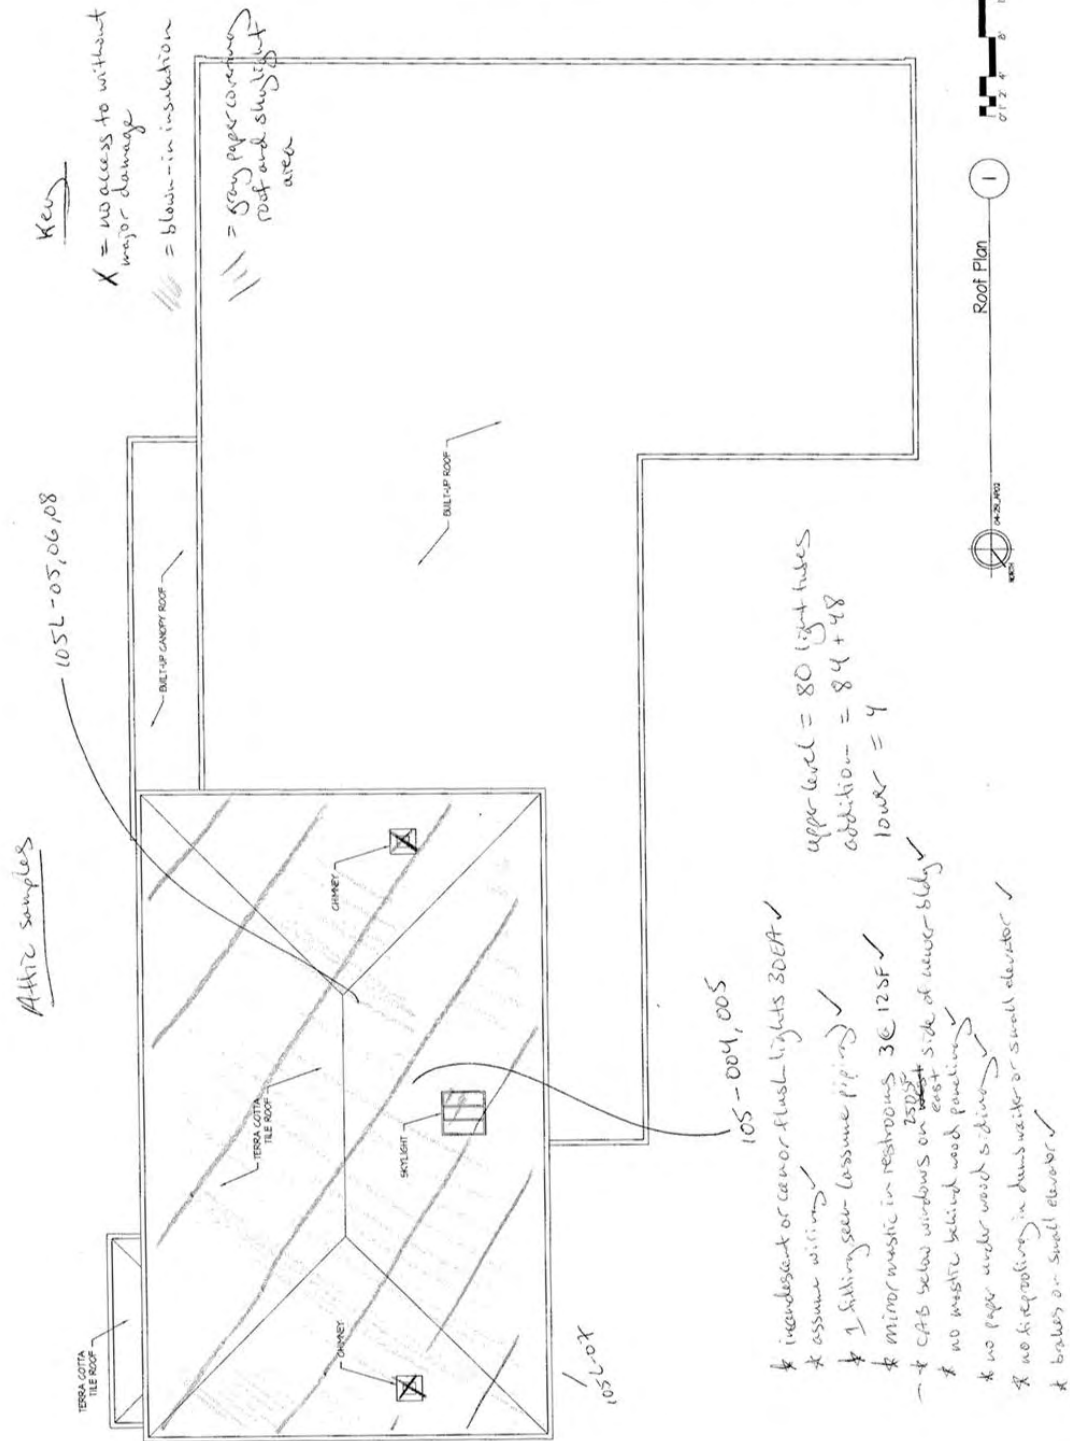
Lower Floor Plan 1
0 1 2 3 4 5 6 7 8 9 10 12
10-25-00

The following pages contain plan diagrams with sample locations identified in this report.
